Manhole Inspection Summary

Manhole # S41WW_017MH

Insp Date: **2/23/07 11:47 AM**

Location Address: **3220 LOCH RAVEN BLVD**

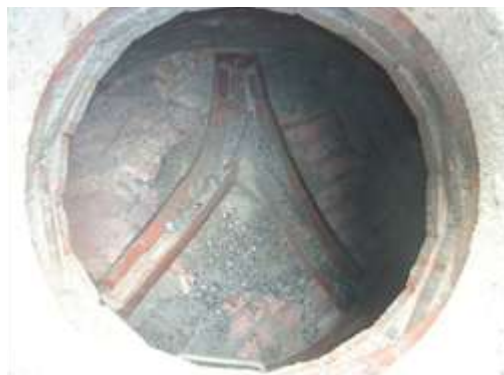
Top View

Frame leaks. Adjustment and Barrel infiltration. Bench and Channel debris.

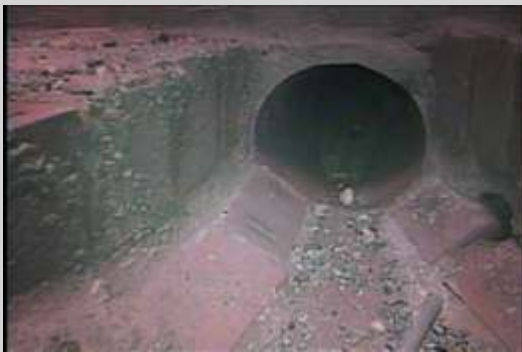
6 in. Circular Gravity Sewer Pipe Out @ 12 O'Clock

Deposits: ☐ None ☒ **Mud** ☐ Sludge ☒ **Debris** ☐ Grease

Silt Depth: **1** (in.) Deposits Extent: **Light**

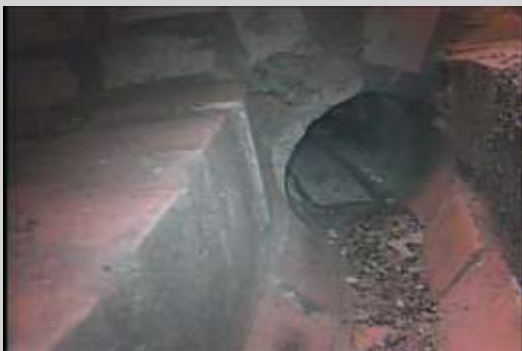
6 in. Circular Gravity Sewer Pipe In @ 4 O'Clock

Deposits: ☐ None ☒ **Mud** ☐ Sludge ☒ **Debris** ☐ Grease

Silt Depth: **0** (in.) Deposits Extent: **Light**

Infiltration: **Evidence** Pipe Seal Cond: **Unknown**

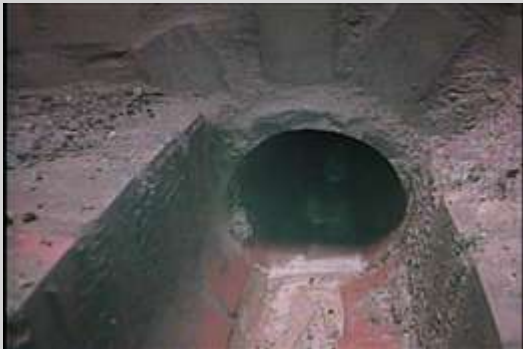
6 in. Circular Gravity Sewer
Pipe In @ 8 O'Clock

Deposits: ☒ None ☐ Mud ☐ Sludge ☐ Debris ☐ Grease

Infiltration: **None** Pipe Seal Cond: **Unknown**
